Microscopic investigation of interface  
corrosion of steel-aluminum explosively  
bonded material exposed to periodic sea  
water spray

Keelean, Michael Richard

Monterey, California. Naval Postgraduate School

September 1976

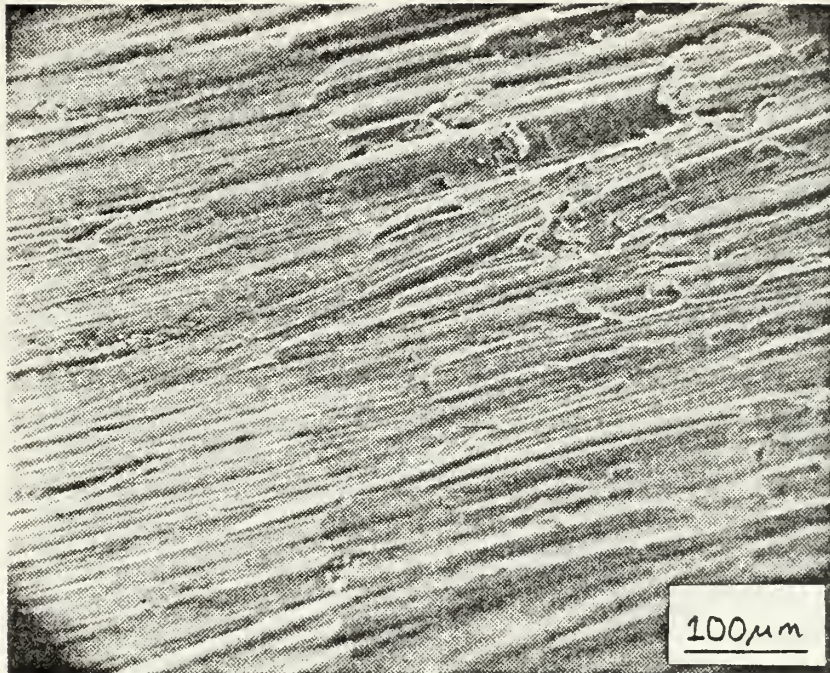
Figure 24. 160x SEM picture of the interface region showing corrosion band after 30-minute exposure and six sprayings (Steel $\longleftrightarrow$ Al).

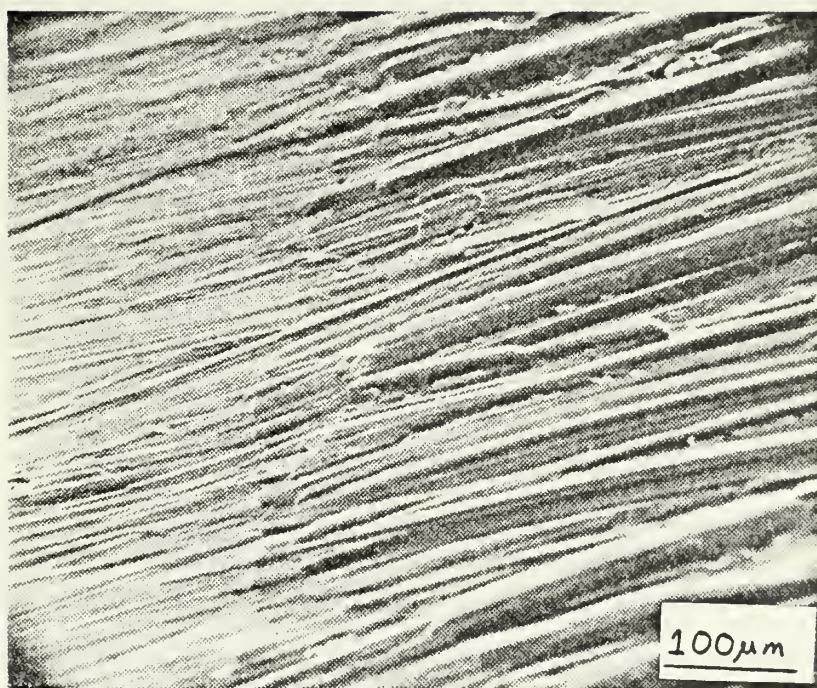
Figure 25. 170x SEM picture of the interface region showing corrosion band after 30-minute exposure and 15 sprayings (Steel $\longleftrightarrow$ Al).

to the steel and experiencing accelerated deterioration. The corrosion attacked the sharpest features most severely but removed metal generally throughout the bond. Thus the ruggedness of the surface appears decreased. As the distance from the interface increased, the galvanic couple had less affect and the concentrated deterioration decreased, while at the interface the line of demarcation sharpened. Although the two samples had contour differences, there did not appear to be any significant differences at the bond that were attributable to variances in the number of spray exposures. Figure 26 is a picture of the bond at a higher magnification. The right side of the corrosion belt is outside of the view of the picture. Localized anodic dissolution pitting appears in the aluminum next to the bond, about 3 cm from the top of the picture. In this photograph an almost indiscernible haze film extends for a relatively short distance on both sides of the interface. For this exposure time, neither specimen showed significant differences from the unexposed samples in the area on the aluminum further from the bond, Figures 27 and 28. On the steel side of the samples, the specimen with the fewest sprayings appeared similar to the unsprayed sample at 340x, Figure 29, while the more frequently sprayed sample showed the first signs of rust deposit formation, Figure 30. No evidence of general film or scale formation was observed on the steel, even when examined up to 5000x.

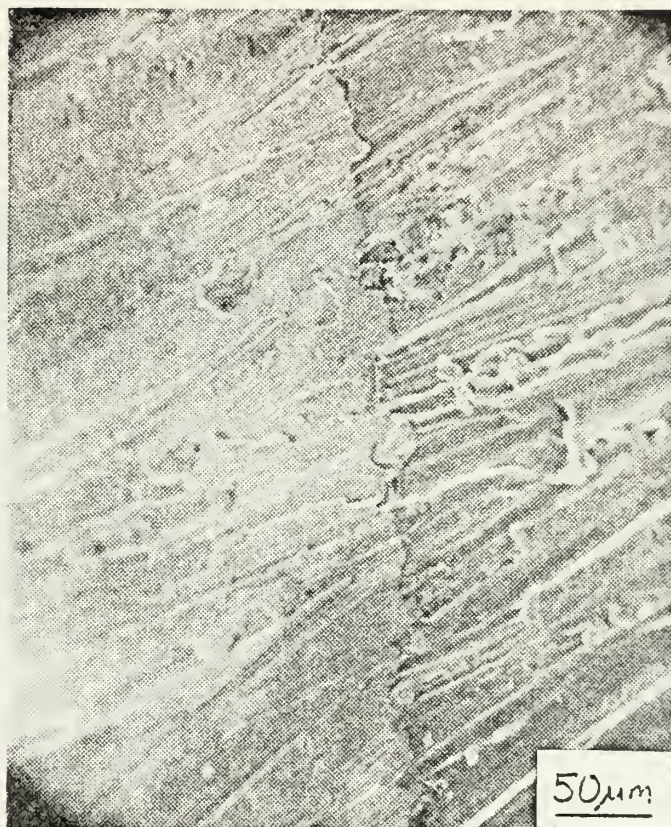
Figure 26. 250x SEM picture of bond area and corrosion belt showing localized anodic dissolution after 30-minute exposure and 15 sprayings (Steel $\longleftrightarrow$ Al).

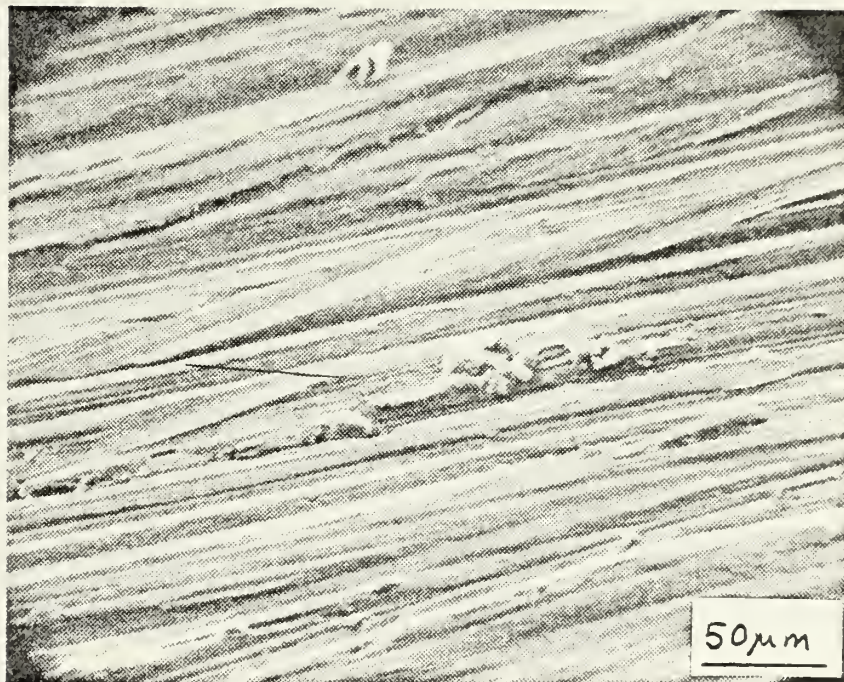
Figure 30. 320x SEM picture of steel away from bond showing initiation of rust deposits after 30-minute exposure and 15 sprayings.

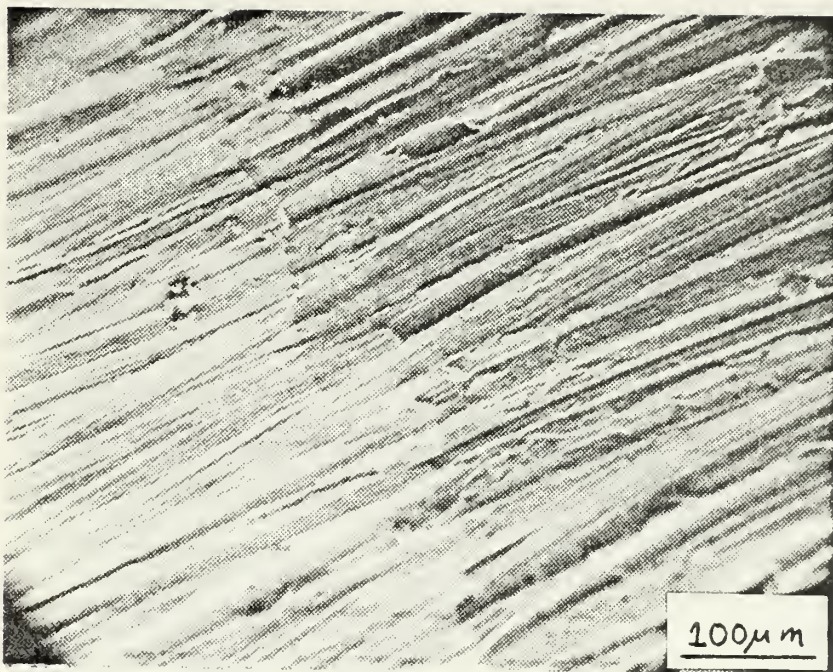
The next pair of samples were removed after one hour, with 12 and 30 sprayings respectively. Again a corrosion belt was visible near the interface, Figure 31, but it seemed to disappear in some areas. The aluminum within this bond appeared smoothed, with distinct ridges separating it from both the steel and the rest of the aluminum. Small clumps of pebble-shaped rust deposits could be seen near the interface on the sample that received more spray. When viewed at a lower magnification the steel side of the interface showed a build-up of an almost transparent film with a few tiny specks of rust popping through. The film build-up was much thicker in places, Figure 32, and could be seen as a white trail originating at the interface. This was probably due to precipitation of the oxide compounds formed at the interface but carried over to the steel by gravitational flow of the solution. Enlarged views of these areas show a build up of snowflake-like particles beginning immediately at the interface on the steel, but a complete absence of these particles on the aluminum, Figures 33 and 34. In Figure 35, the interface was enlarged to 1300x. At this magnification a distinct area of micro-anodic activity can be seen. Slightly to the top left of center in this picture there is a relatively deep valley in the aluminum adjacent to the bond face. The white trail previously described was located near this pit. As one might expect, areas of high interface activity generally were adjacent to heavy deposit trails. Again, for this

Figure 31. 175x SEM photograph of the interface illustrating the corrosion band and small clumps of rust after one-hour exposure and 30 sprayings (Steel $\longleftrightarrow$ Al).

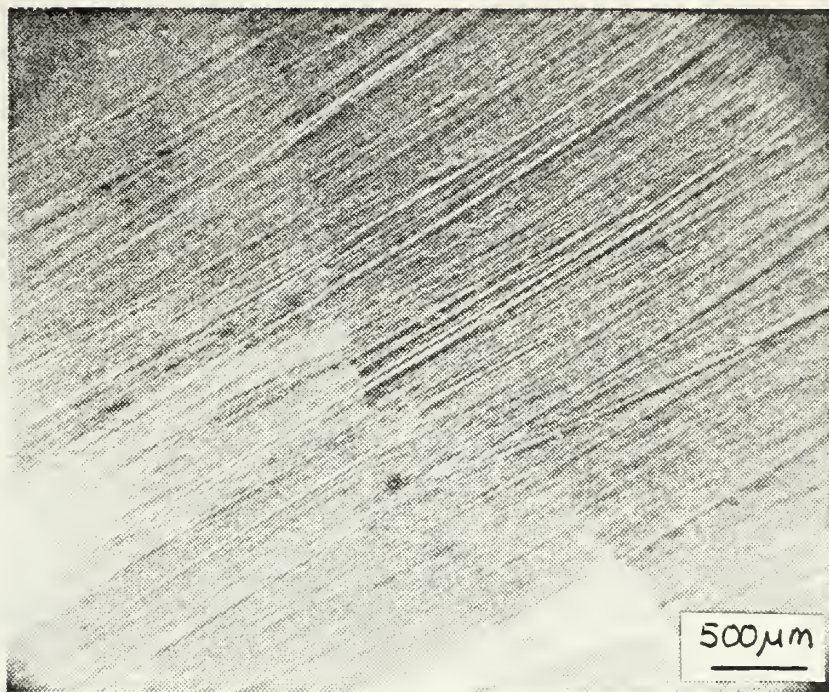
Figure 32. 25x SEM photograph showing the bond interface with trail of white deposits on the steel after one-hour exposure and 12 sprayings (Steel $\longleftrightarrow$ Al).

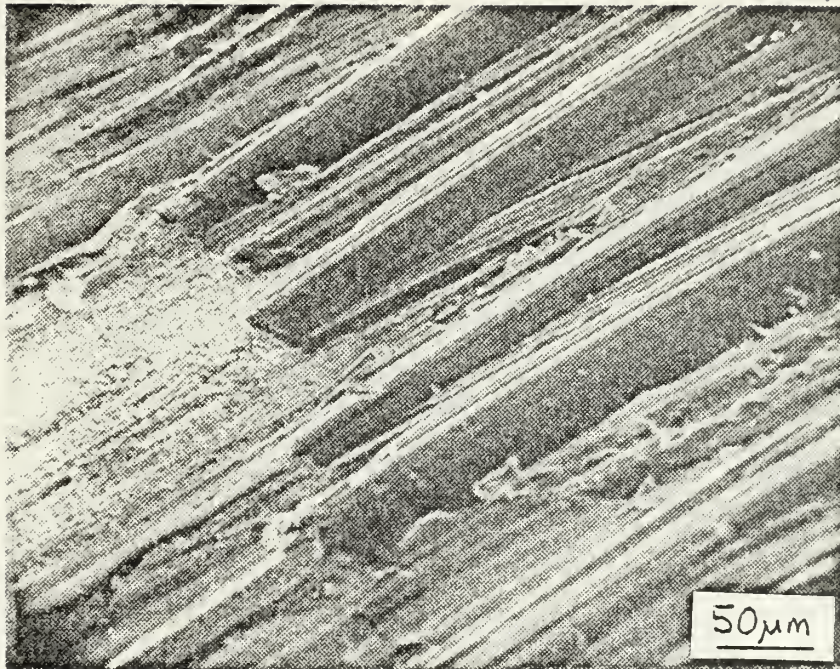
Figure 33. 250x SEM picture of interface showing small deposits on steel after one-hour exposure and 12 sprayings (Steel $\longleftrightarrow$ Al).

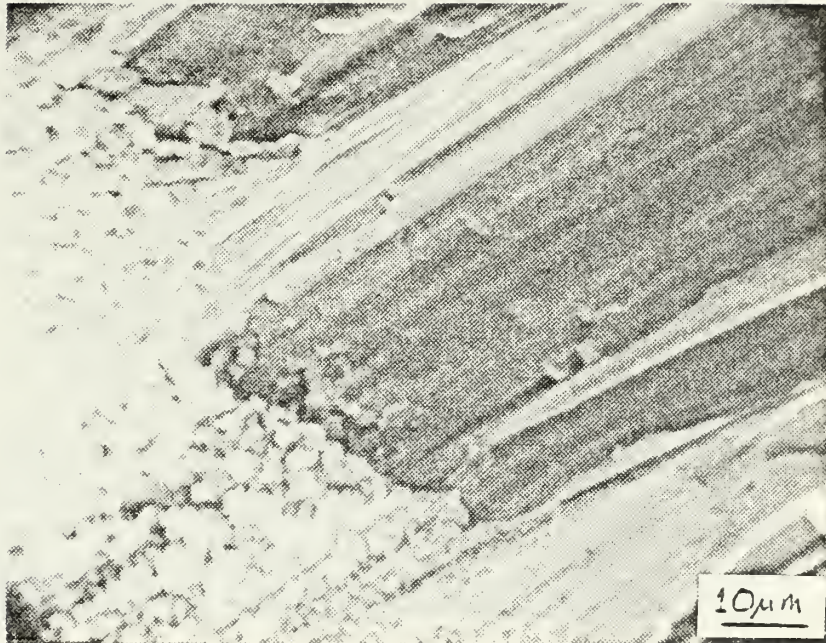
Figure 34. 1100x SEM photograph of interface showing snowflake-like build-up on steel with no build-up on the aluminum. Sample had one-hour exposure and 12 sprayings (Steel $\longleftrightarrow$ Al).

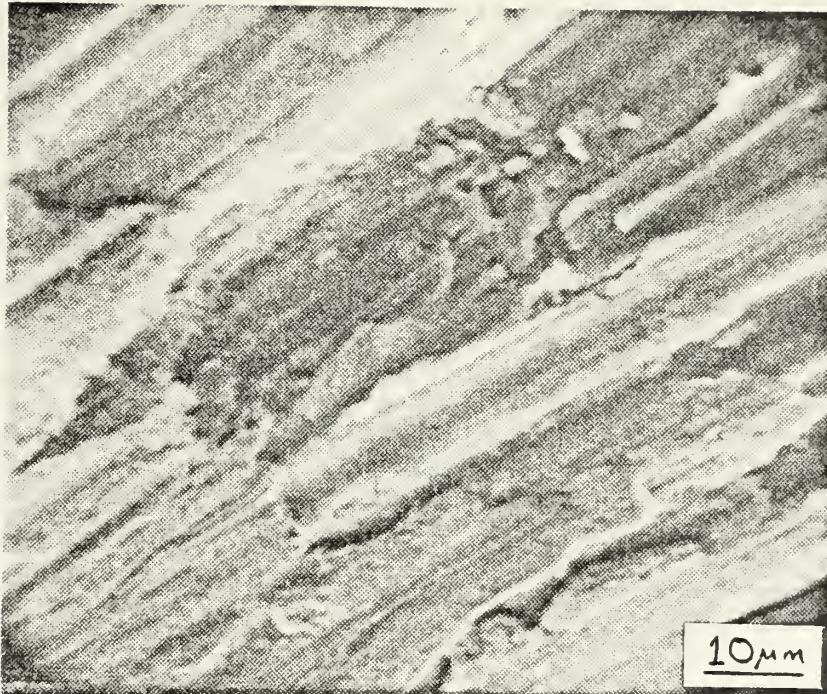
Figure 35. 1300x SEM picture of interface after one-hour exposure and 12 sprayings shows microanodic valley.

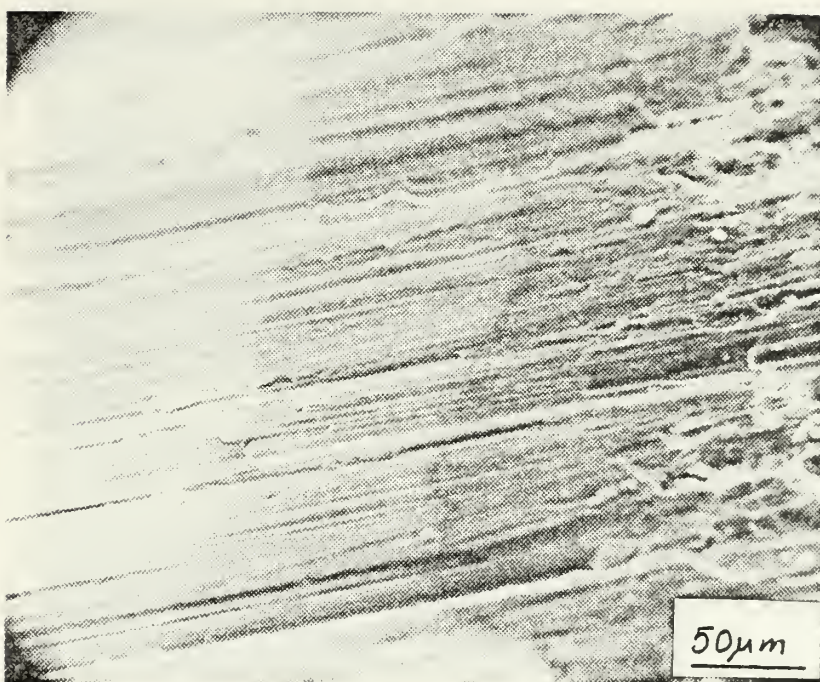
Figure 38. 290x SEM photograph of interface after two-hour exposure showing belt zone and adjacent films (Steel $\longleftrightarrow$ Al).

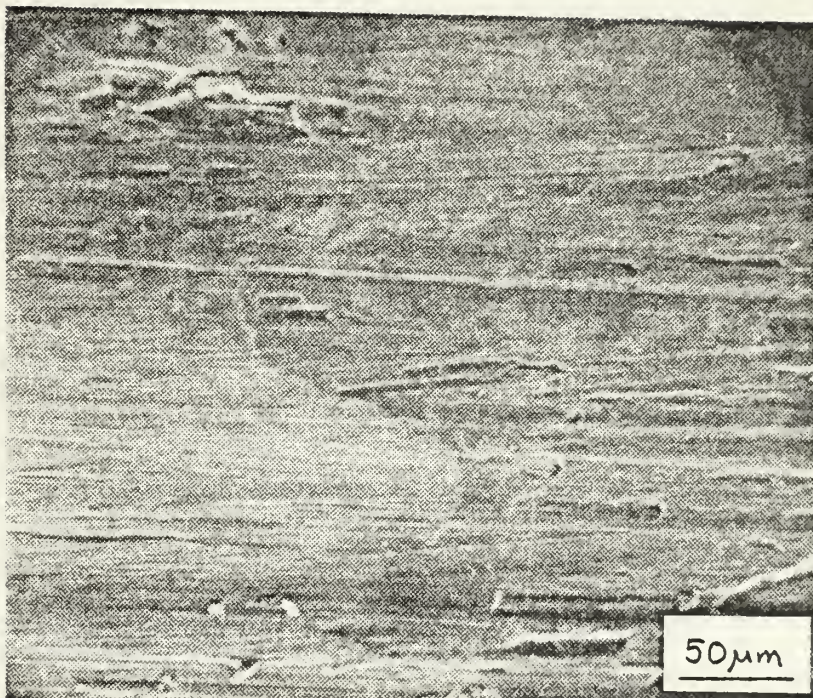
Figure 39. 300x SEM picture of interface after two-hour exposure showing hazy film coverage over most areas (Steel $\longleftrightarrow$ Al).

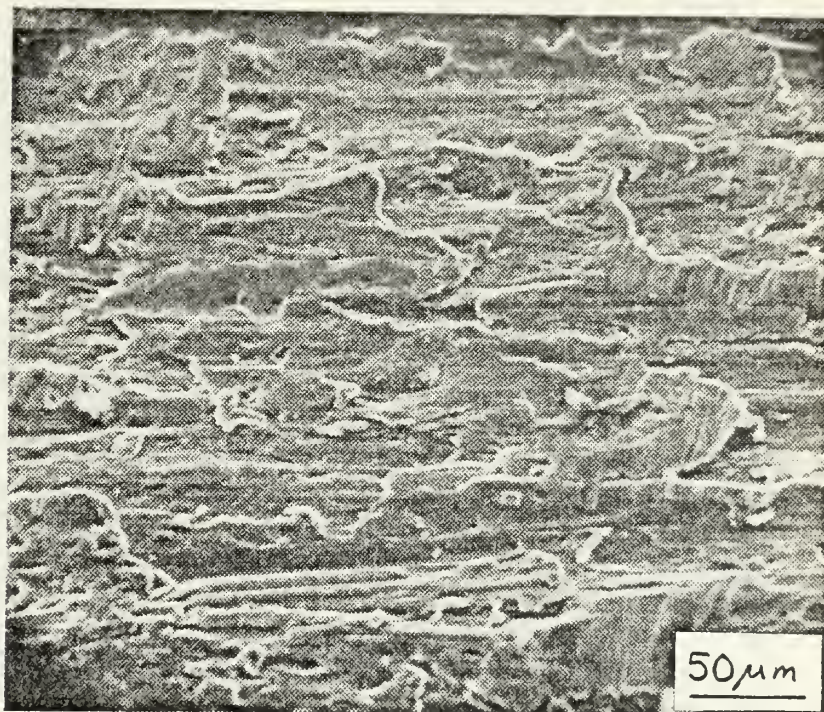
Figure 40. 300x SEM photograph of aluminum after two-hour exposure. It shows general surface deterioration and loss of features.

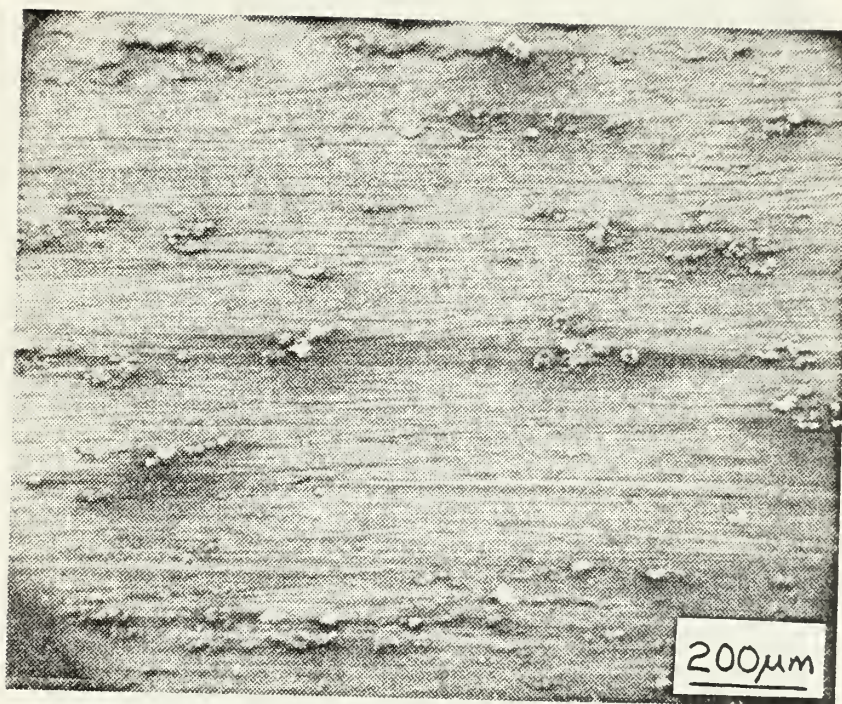
Figure 41. 75x SEM picture of rust nodules formed over layer of alumina film on steel after two-hour exposure.

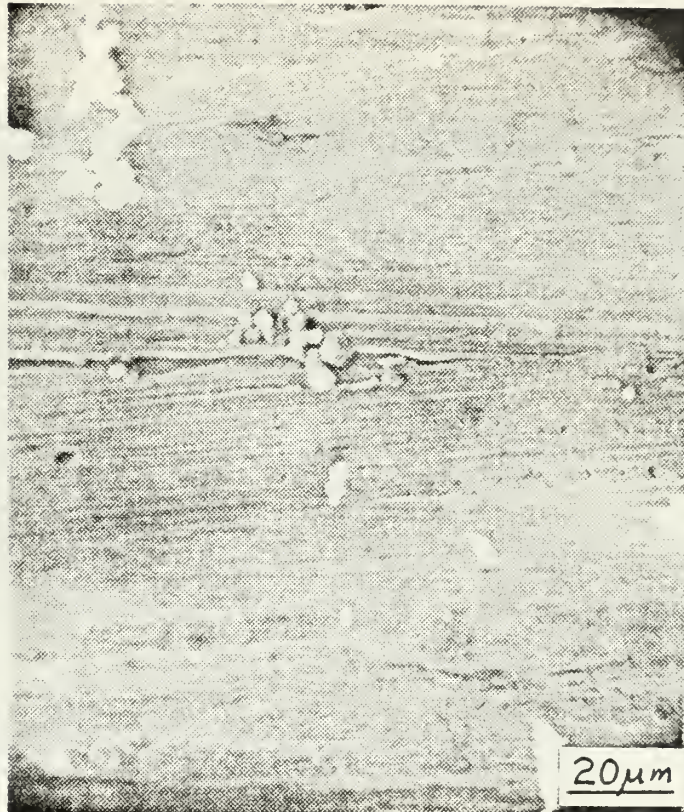
Figure 42. 700x SEM picture of beginning of rusting at surface deformity on steel after two-hour exposure.

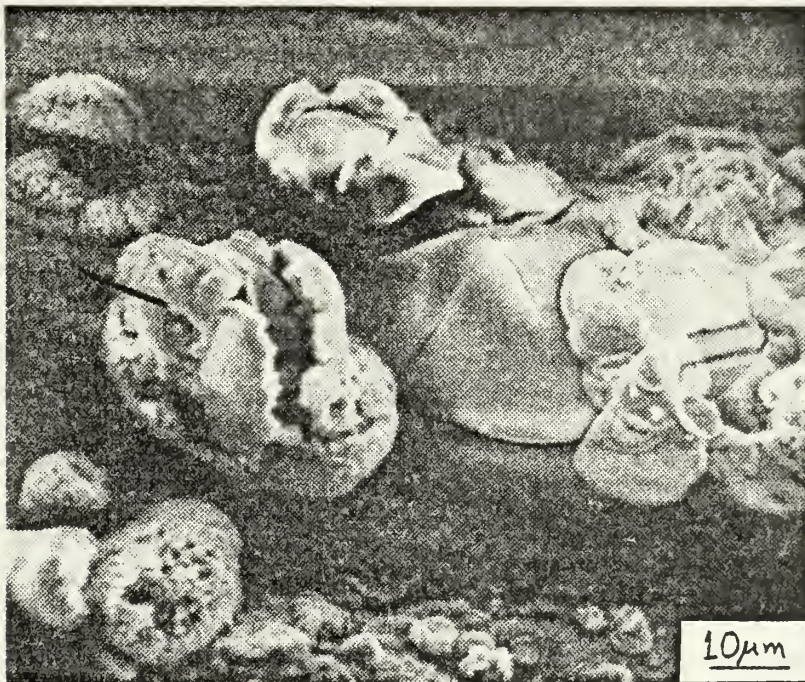
Figure 43. 1050x SEM picture of rust particles on steel surface after two-hour exposure.

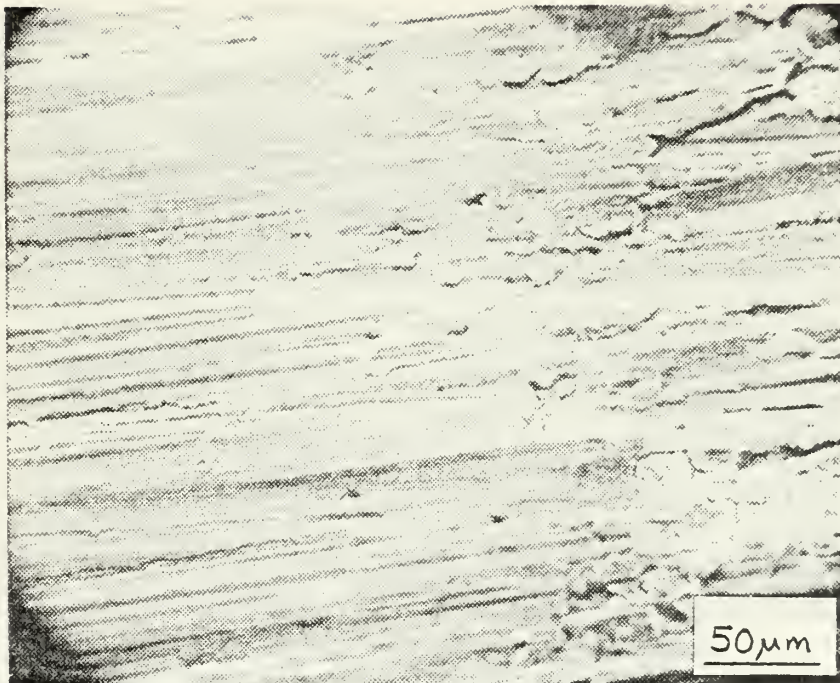
Figure 44. 305x SEM picture of bond area after six-hour exposure shows heavy corrosion obscuring the interface (Steel $\longleftrightarrow$ Al).

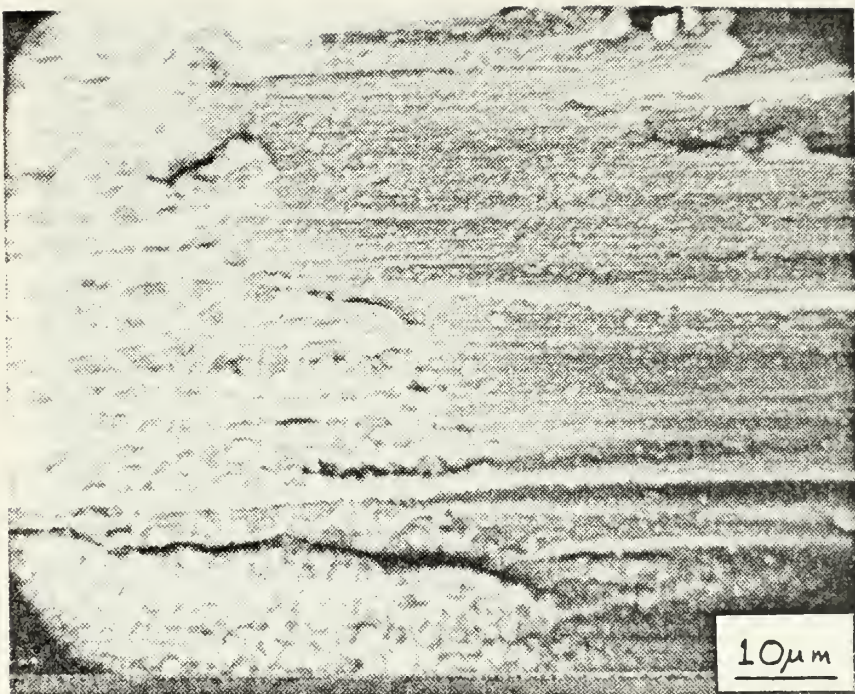
Figure 45. 1350x SEM photograph of bond area after six-hour exposure showing general scale growth on the steel and a base scale growth starting to cover the aluminum (Steel $\longleftrightarrow$ Al).

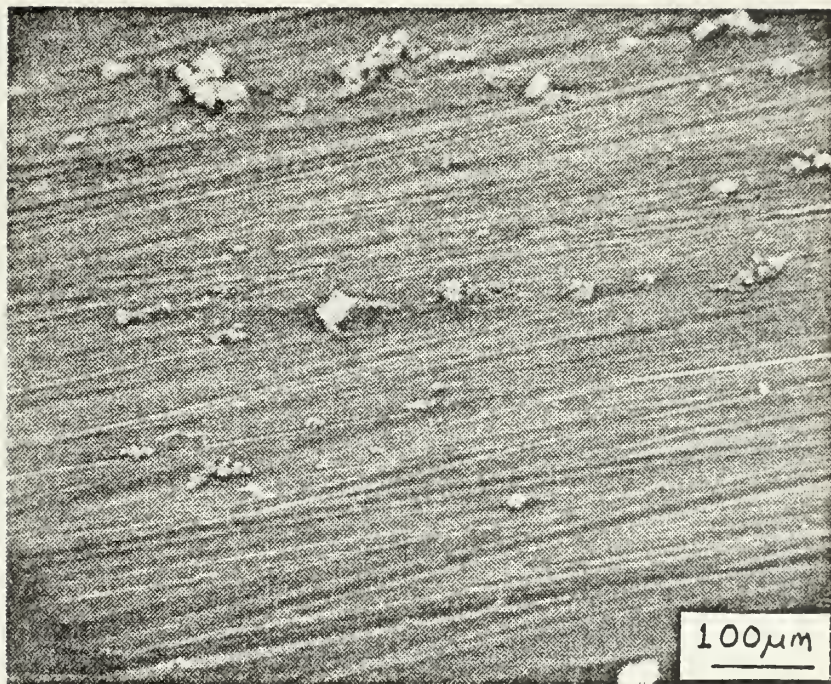
Figure 53. 130x SEM picture of steel with coating of alumina and rust nodules after 12-hour exposure.

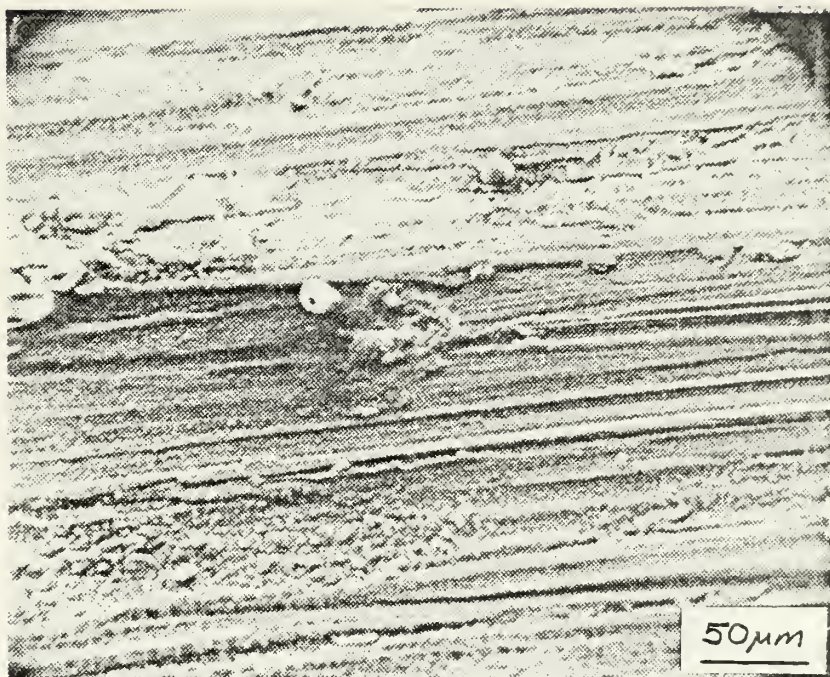
Figure 54. 280x SEM picture showing iron oxide growth in alumina coating on steel after 12-hour exposure.

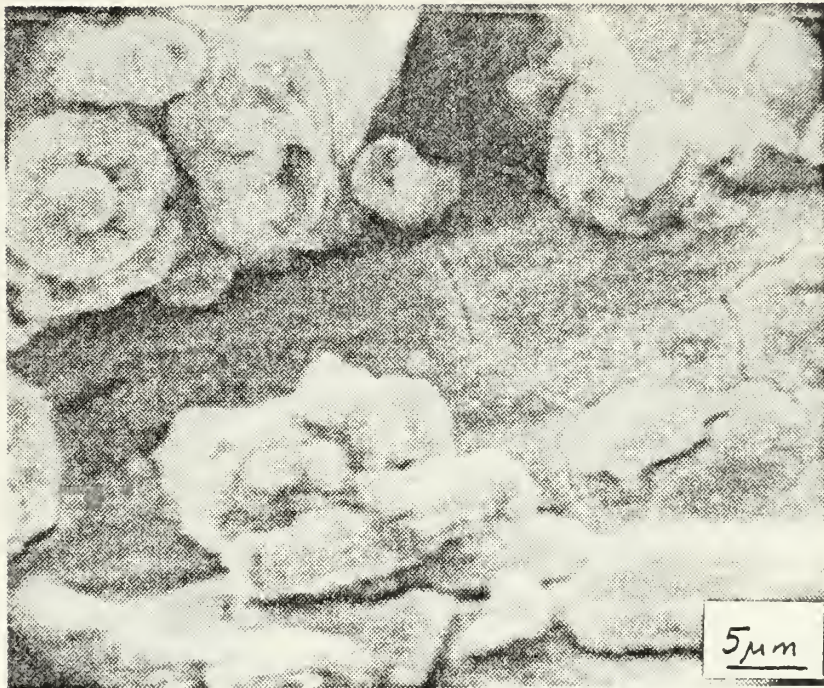
Figure 55. 2050x SEM picture showing iron oxide growth through film of alumina on steel after 12-hour exposure.

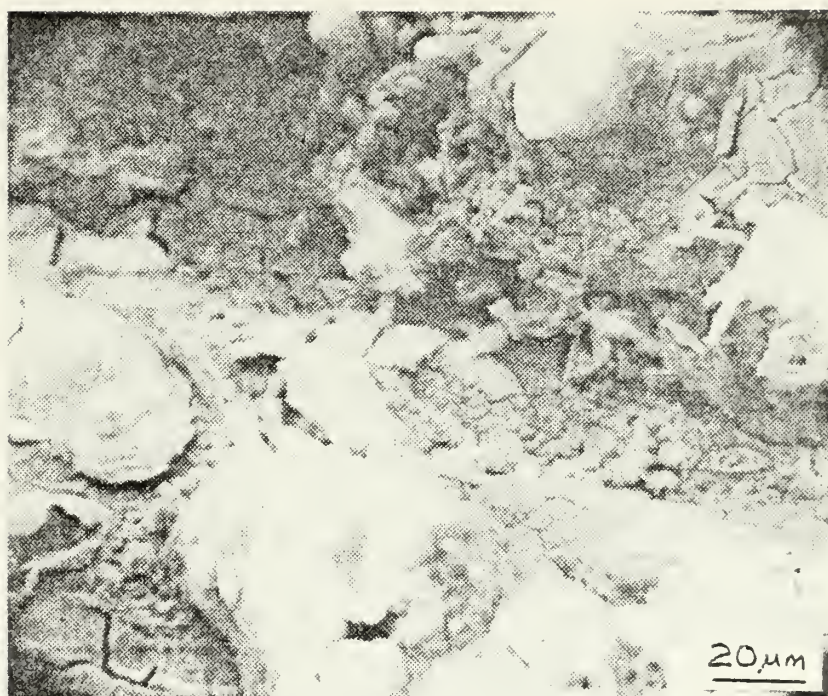
Figure 56. 600x SEM photograph of rust and alumina formation on steel after 12-hour exposure.

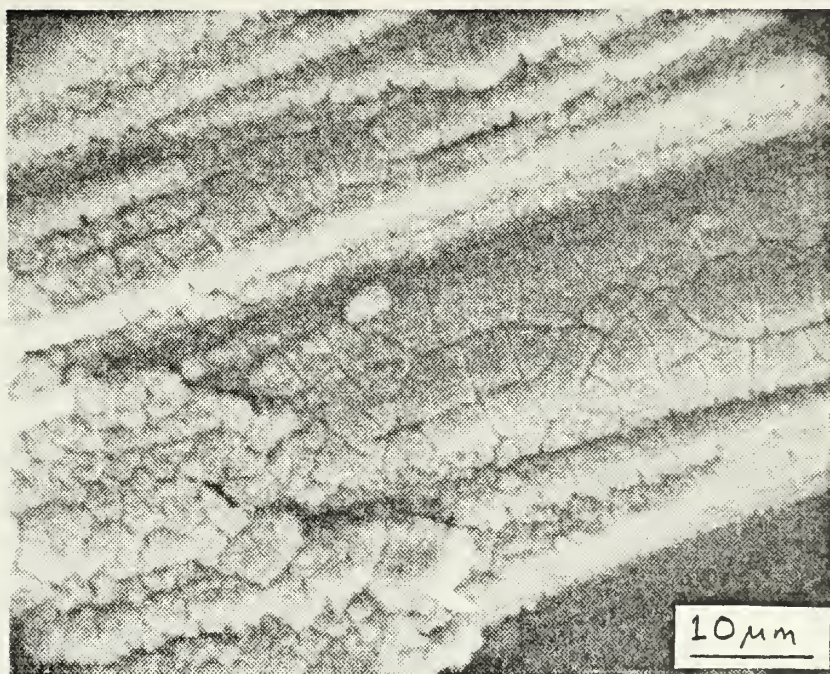
Figure 58. 1600x SEM picture of bond area showing complete coverage by alumina after one-day exposure (Steel $\longleftrightarrow$ Al).

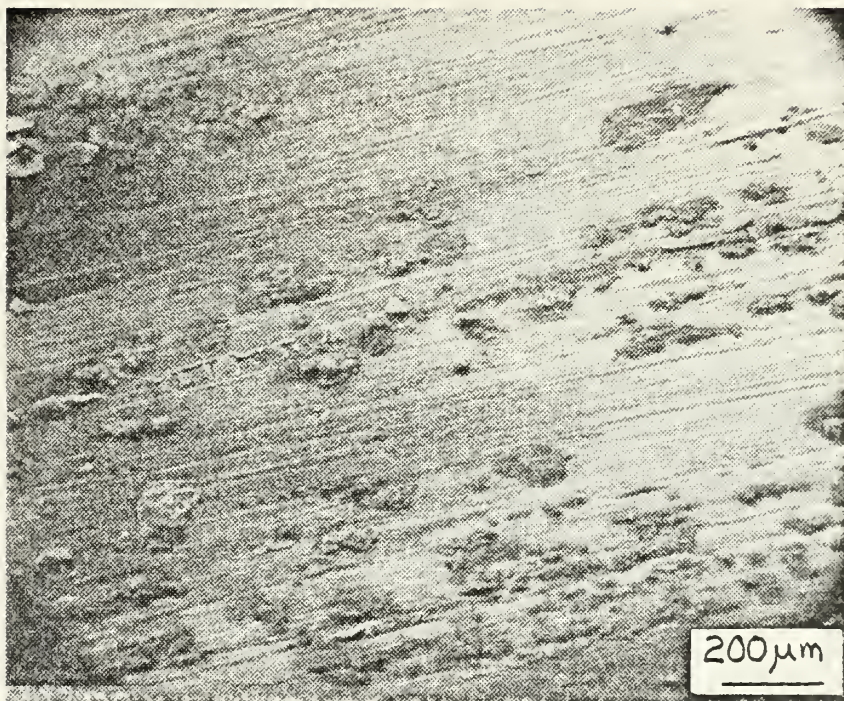
Figure 60. 65x SEM picture of rusting on steel half of sample after two-day exposure.

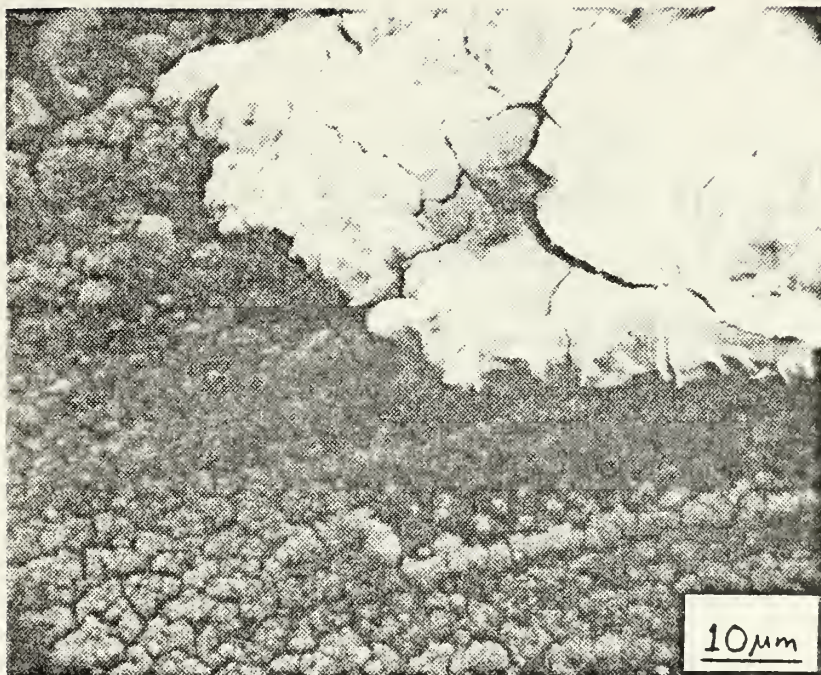
Figure 61. 1300x SEM picture of rust exploding through layer of alumina scale after two-day exposure.

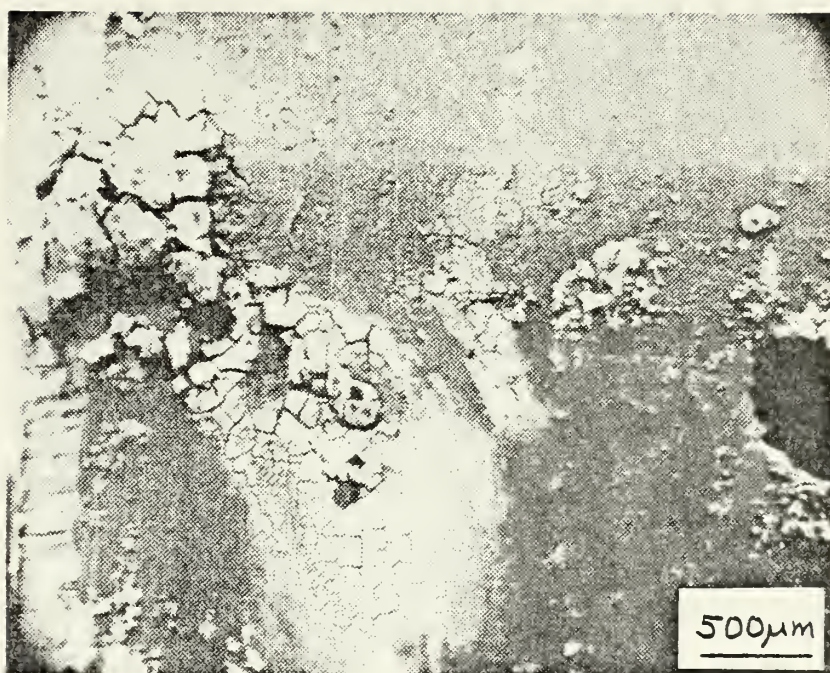
Figure 62. 28x SEM picture of bond zone on five-week exposure specimen showing scaly corrosion product and void (Al over Steel).

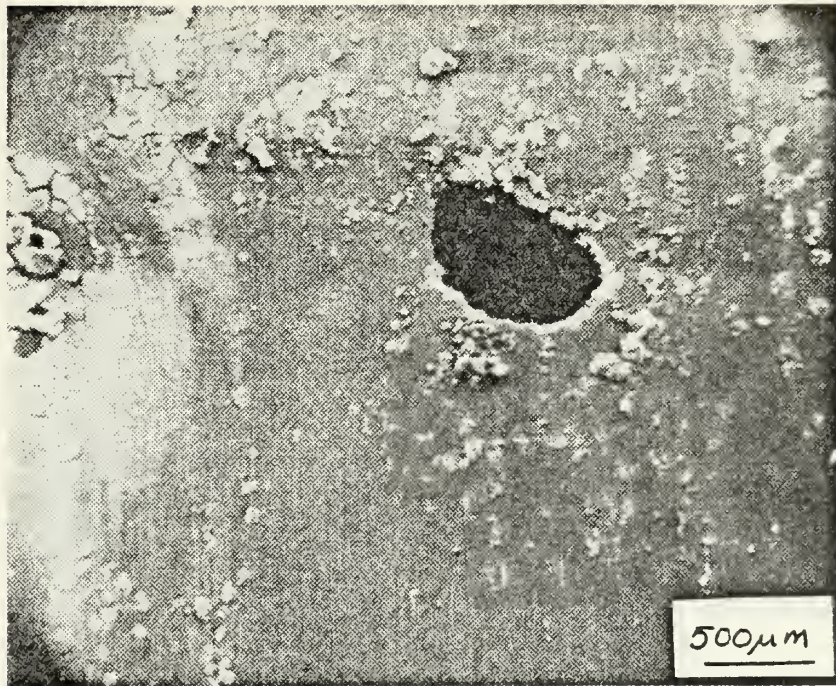
Figure 64. 28x SEM photograph of bond zone on five-week exposure sample showing void and wave outline (Al over Steel).

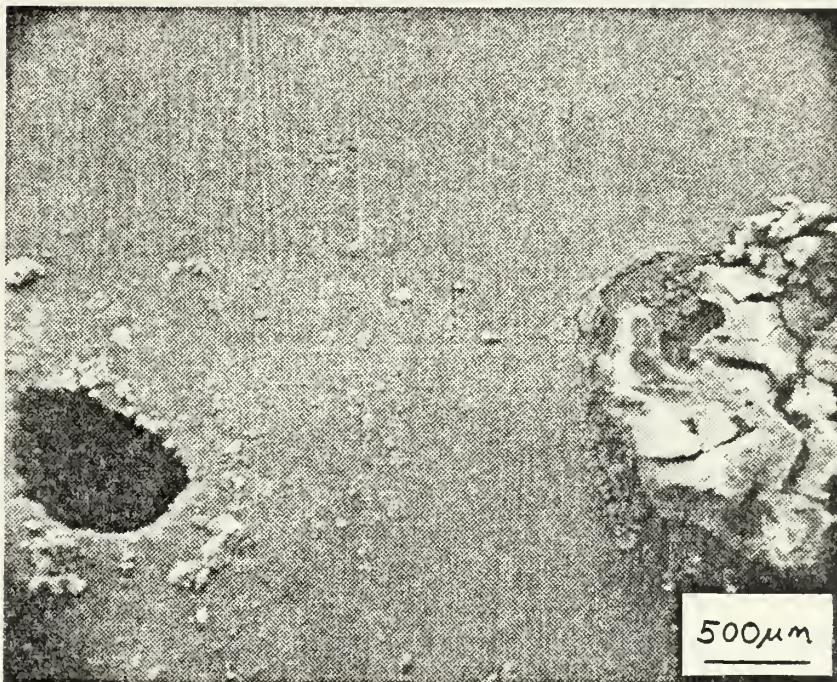
Figure 65. 28x SEM picture of bond zone on five-week exposure sample with void, wave outline, and mushroom-shaped formation (Al over Steel).

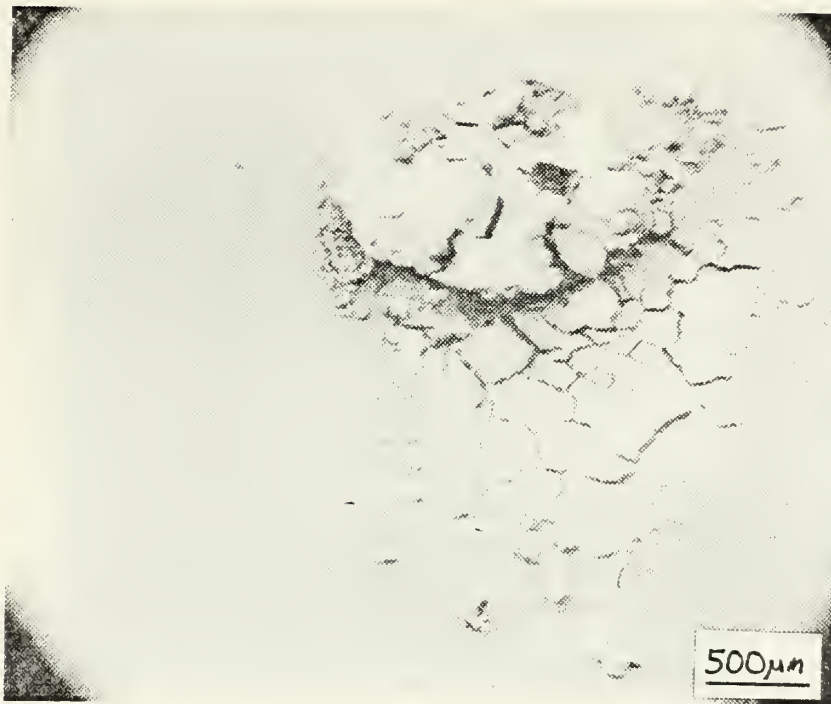
Figure 67. 27x SEM photograph of mushroom-shaped corrosion product on five-week exposure sample.

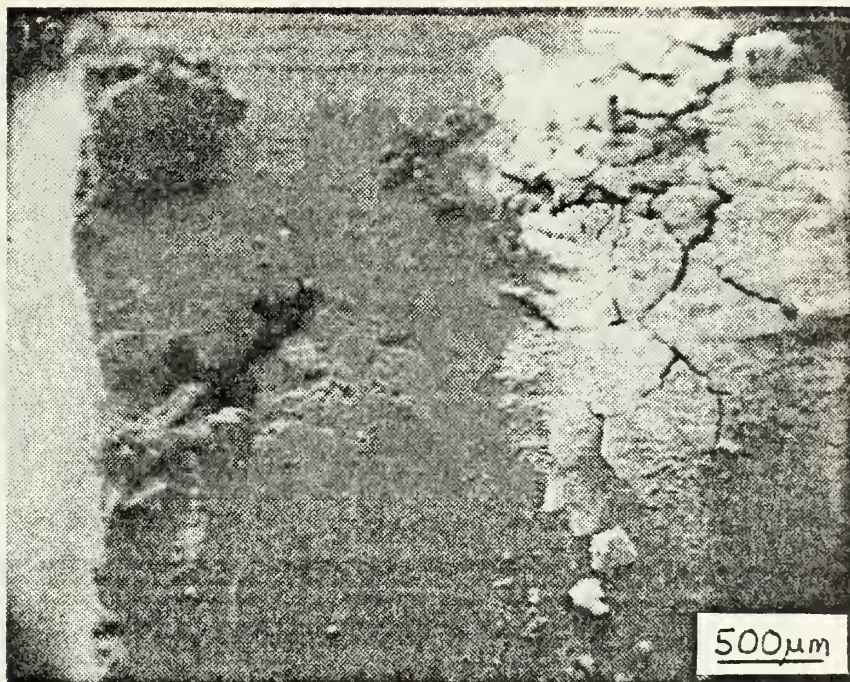
Figure 68. 27x SEM picture of nine-week exposure sample showing pitting and mushroom corrosion product build-up (Al over Steel).

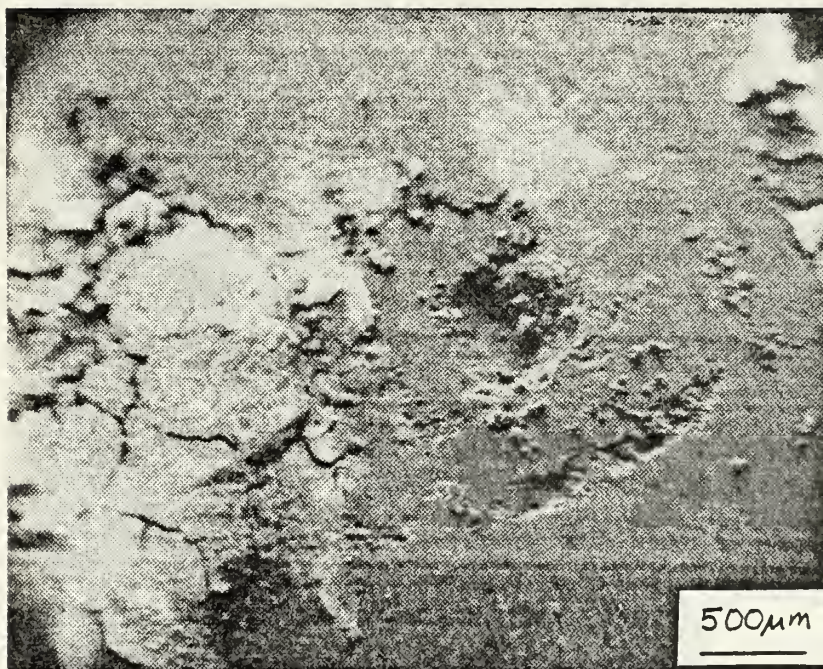
Figure 69. 27x SEM picture of nine-week exposure sample showing mushroom corrosion growth and melt pitting in wave (Al over Steel).

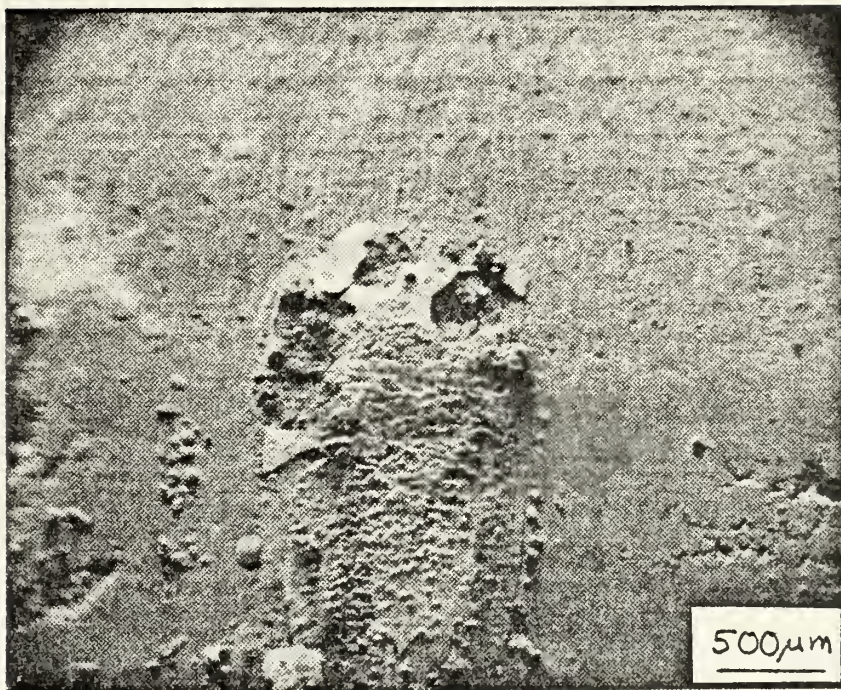
Figure 70. 27x SEM picture of nine-week exposure sample showing pitting, corrosion product growth, and wave outline (Al over Steel).
